2023 Lake Parker Water Quality Monitoring Results: Lay Monitoring Program and LaRosa Partnership Program

Mark Mitchell, Limnologist

UVM Lake Champlain Sea Grant and VT DEC Lakes & Ponds Program

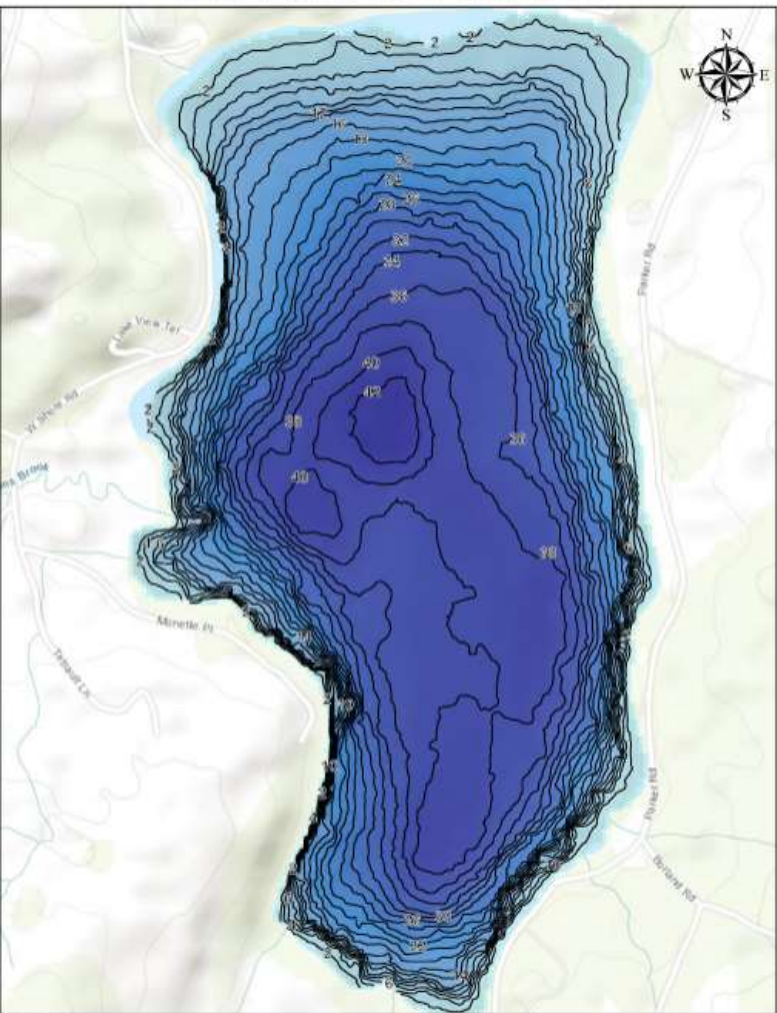
Lake Parker, West Glover, VT

Legend
Depth (ft.)
 High : 0
 Low : 44

— Depth Contour (2 ft.)

Source Data Collected: 8/14/2018

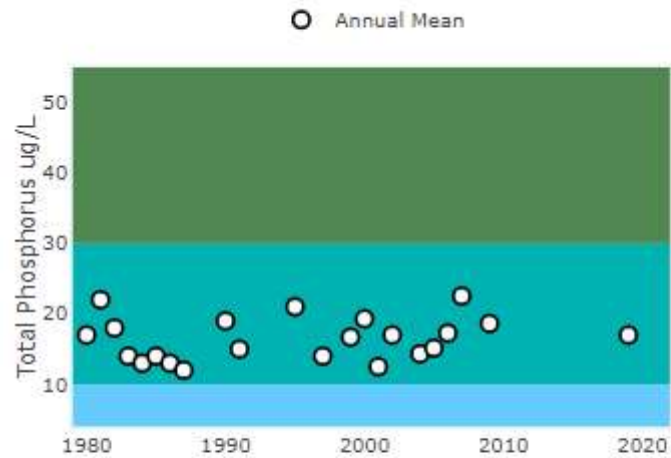
Spring Phosphorus

Trend: Stable (p-value=0.3361)

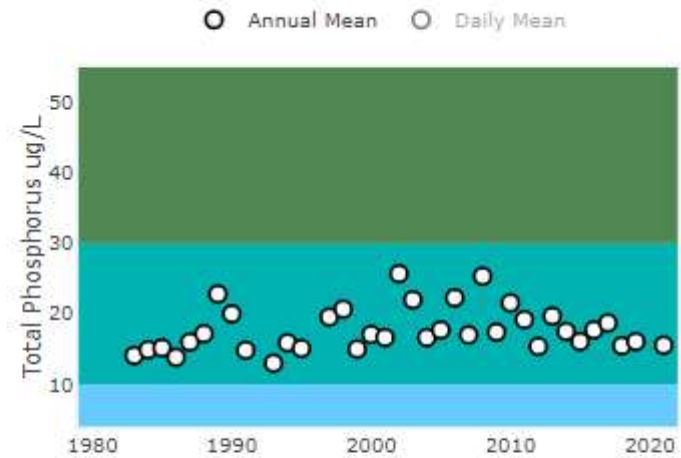
Summer Phosphorus

Trend: Stable (p-value=0.0993)

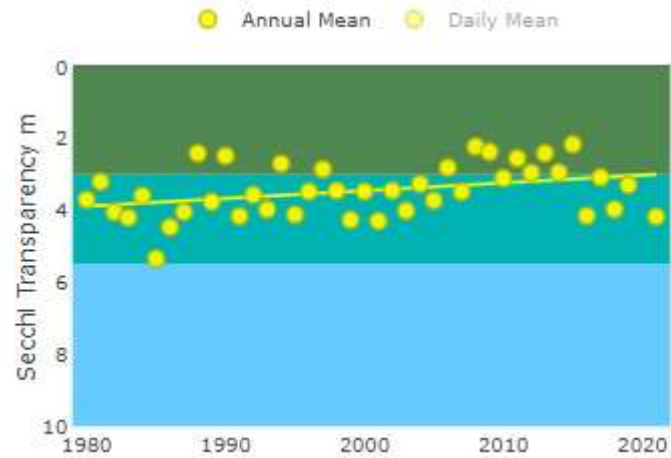
Summer Secchi

Trend: Significantly Decreasing (p-value=0.0262)

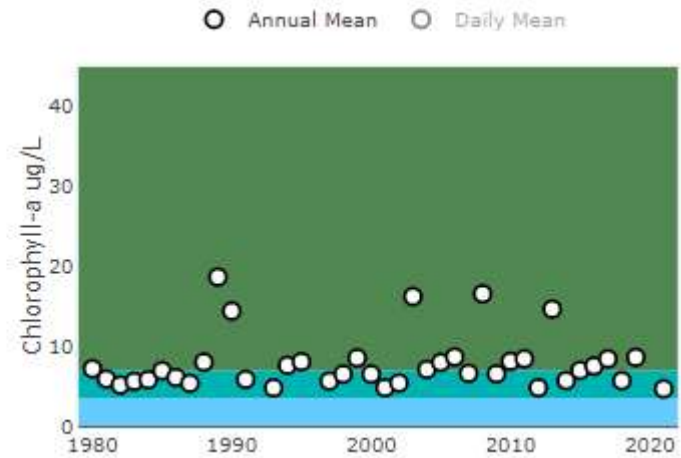
Summer Chlorophyll-a

Trend: Stable (p-value=0.271)

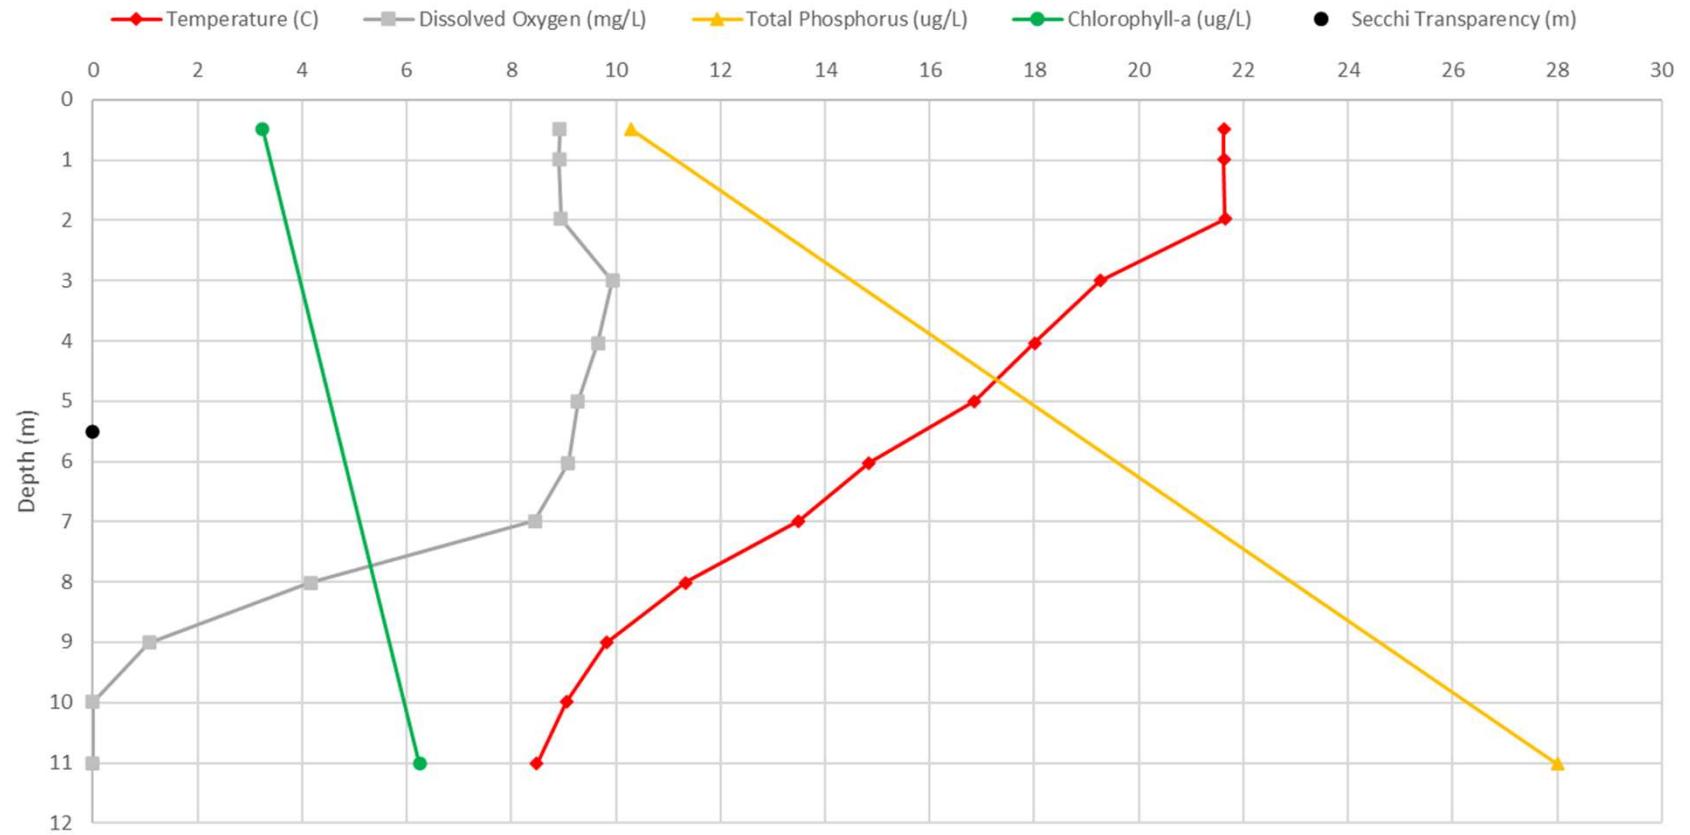
Lake Parker Water Quality Vertical Profile 6/28/2023

- Lay Monitoring Program (LMP)
 - 2023 Summary: Total phosphorus and chlorophyll-a concentrations were initially low in the epilimnion and elevated in the hypolimnion due to internal loading from anoxic sediment in June. After early July flood epilimnetic concentrations increased and then decreased, tracking similarly to hypolimnetic concentrations and Secchi transparency

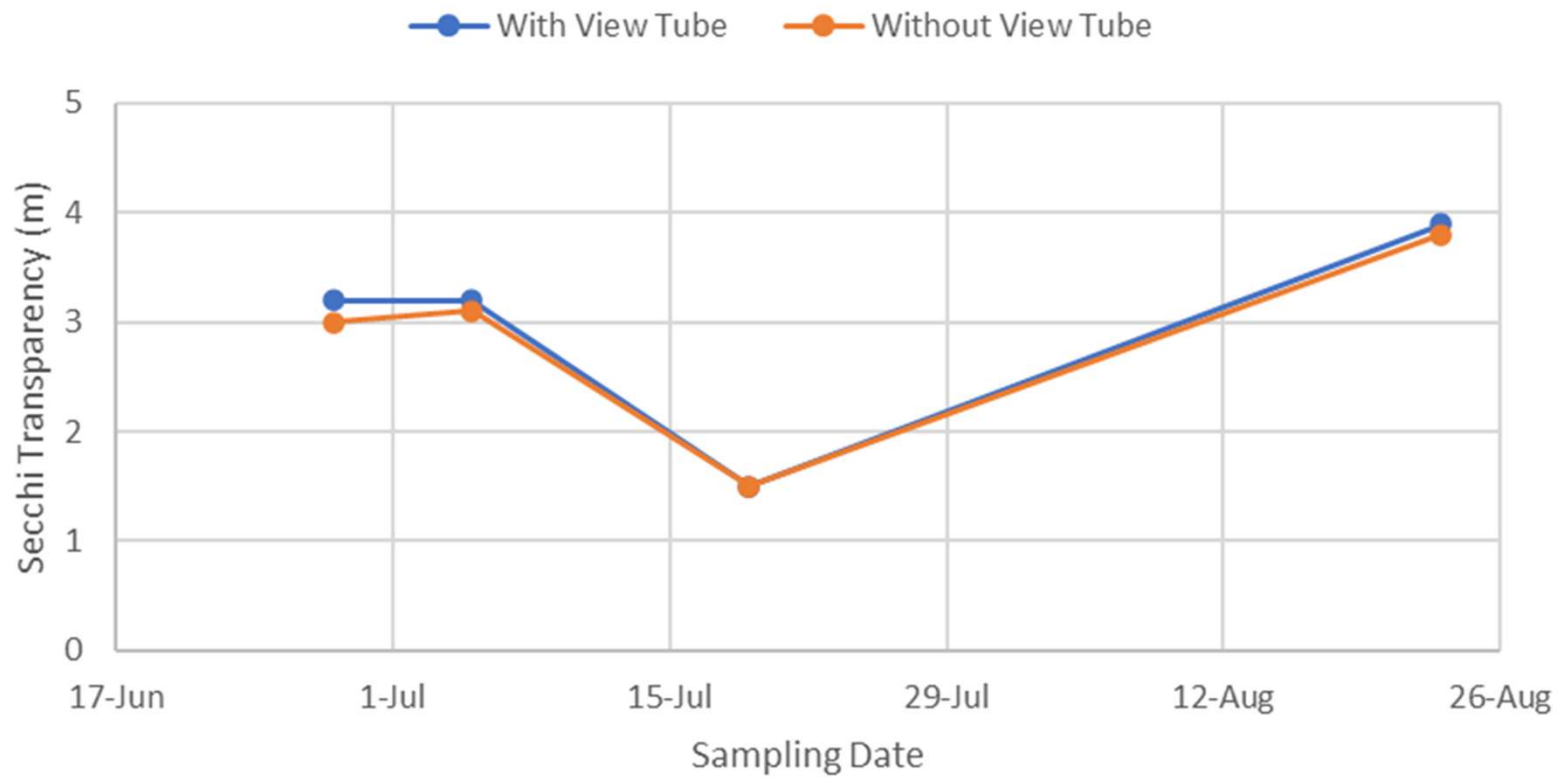
2023 Lake Parker Lay Monitoring Secchi Transparency

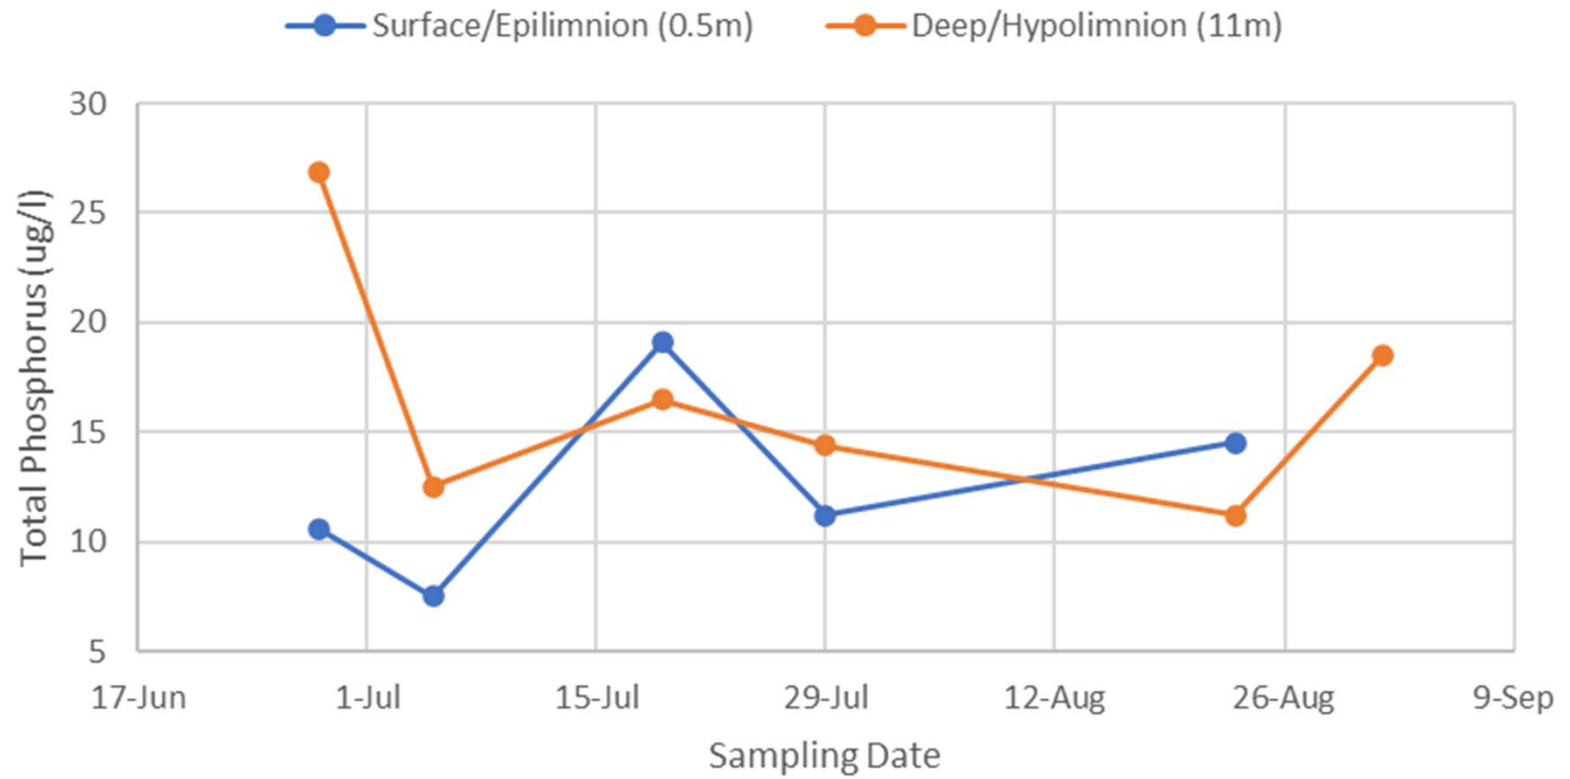
2023 Lake Parker Lay Monitoring Total Phosphorus

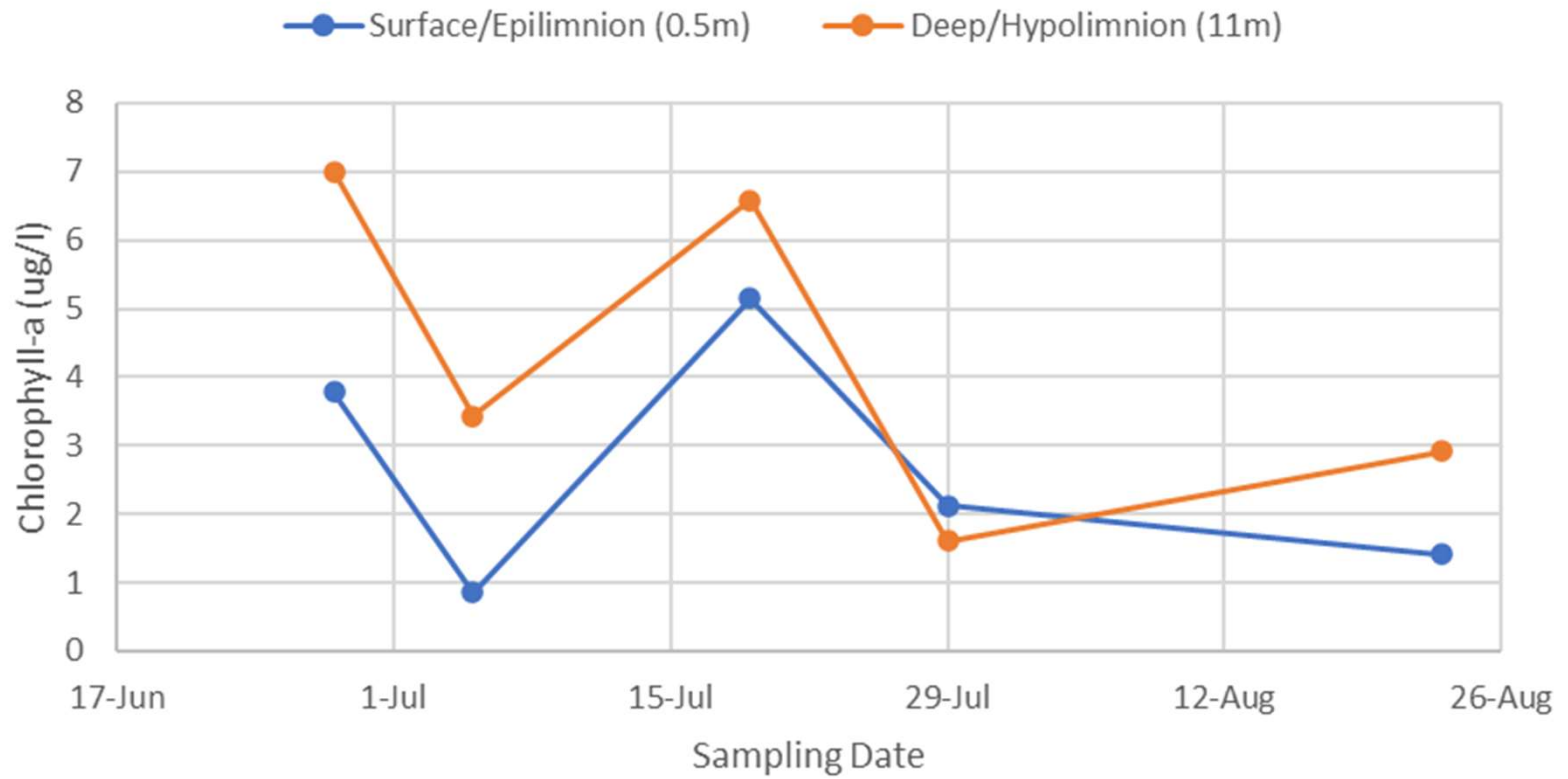
2023 Lake Parker Lay Monitoring Chlorophyll-a

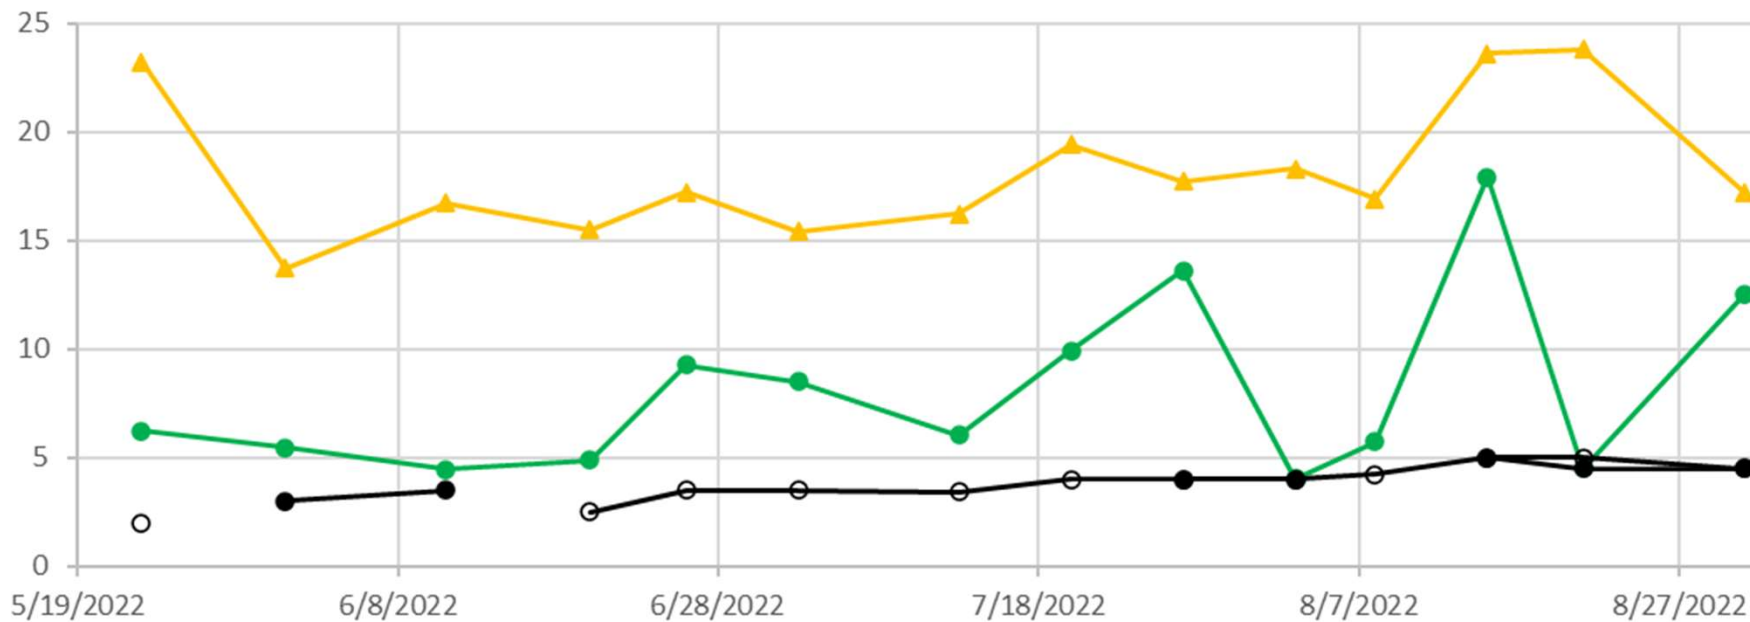
2022 Lake Parker Lay Monitoring Results

—▲— Hose Total Phosphorus (ug/l) —●— Hose Chlorophyll-a (ug/l)
—●— Secchi Depth Without View Tube (m) —○— Secchi Depth With View Tube (m)

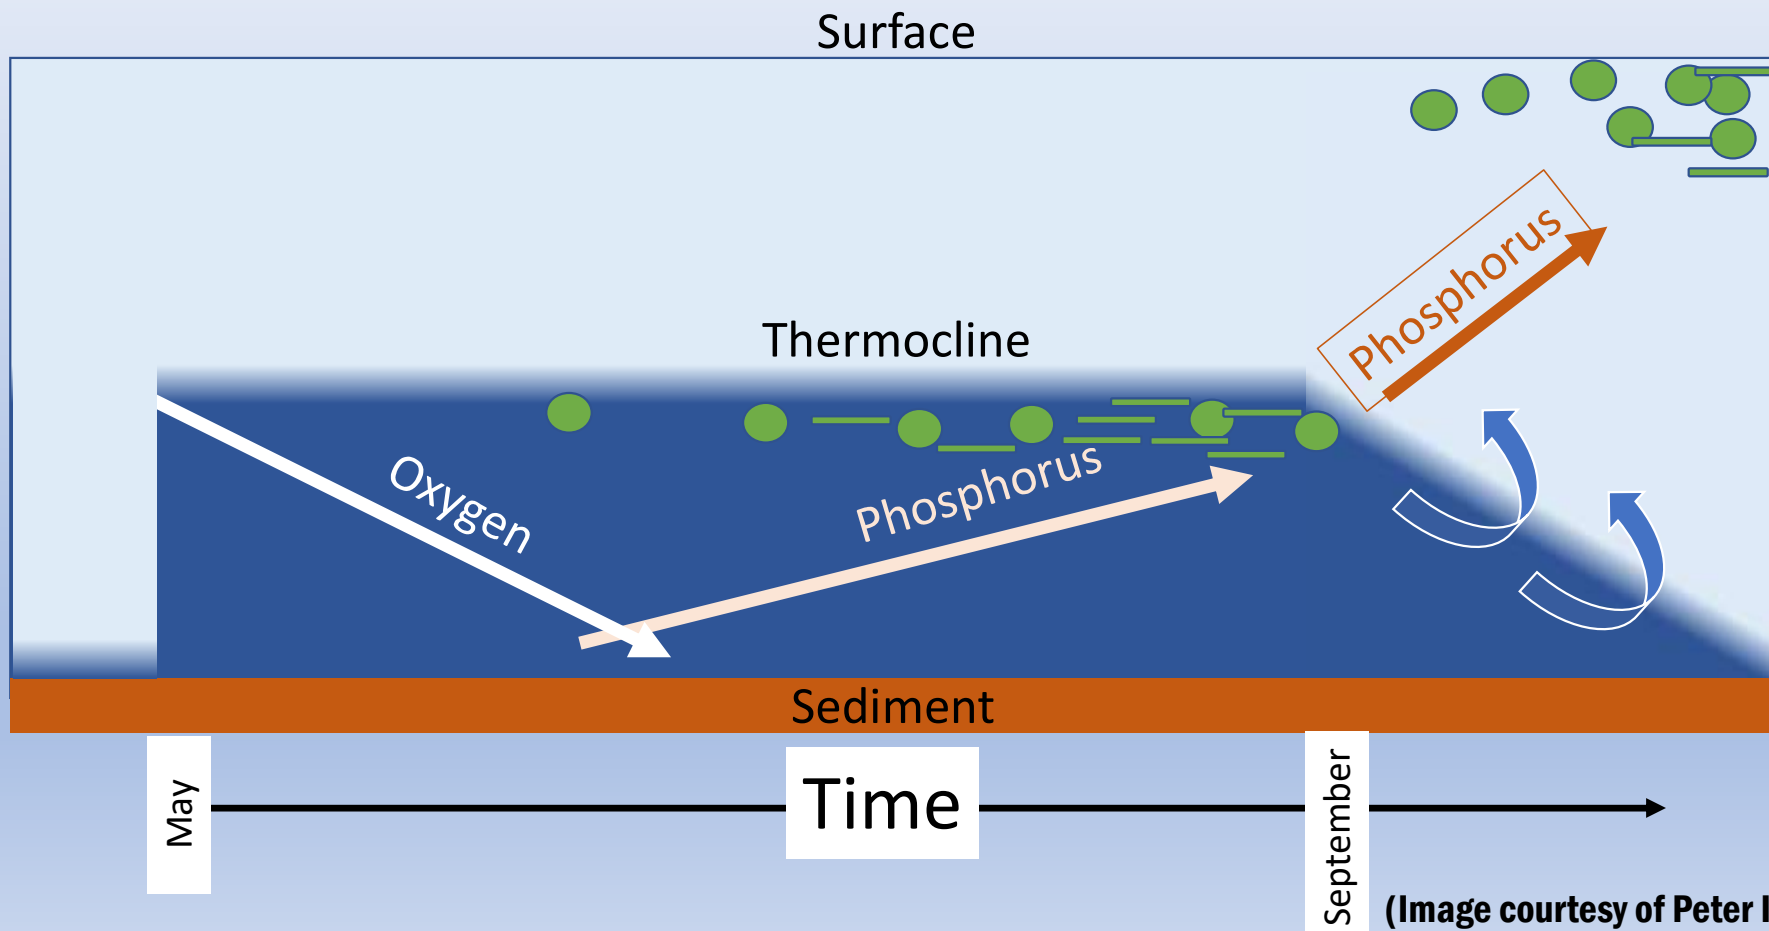
Internal Phosphorus Loading From Anoxic Sediment

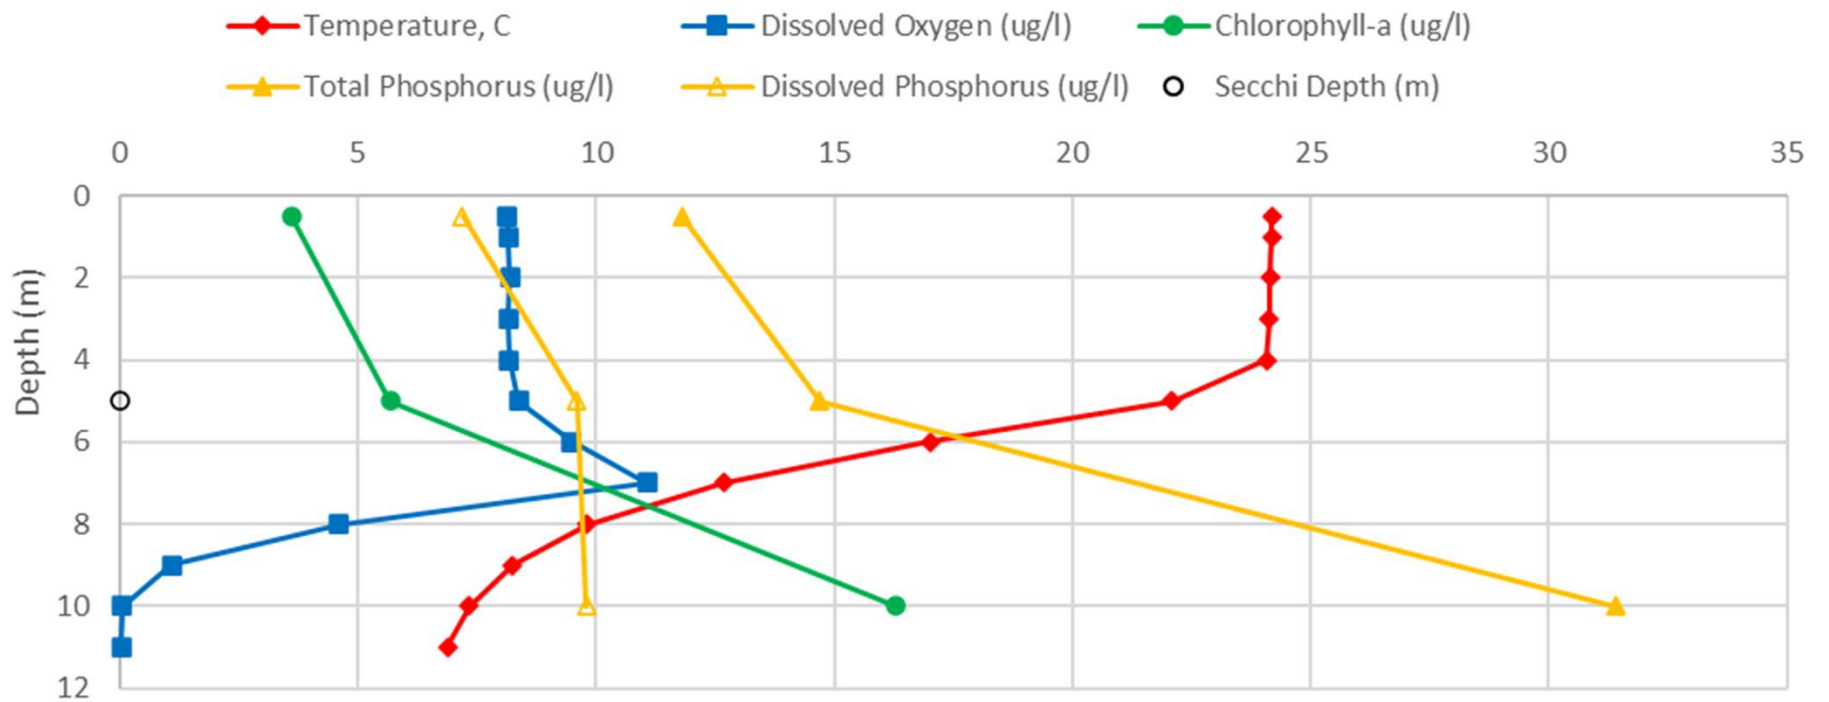
Lake Parker Water Quality Vertical Profile on July 29, 2022

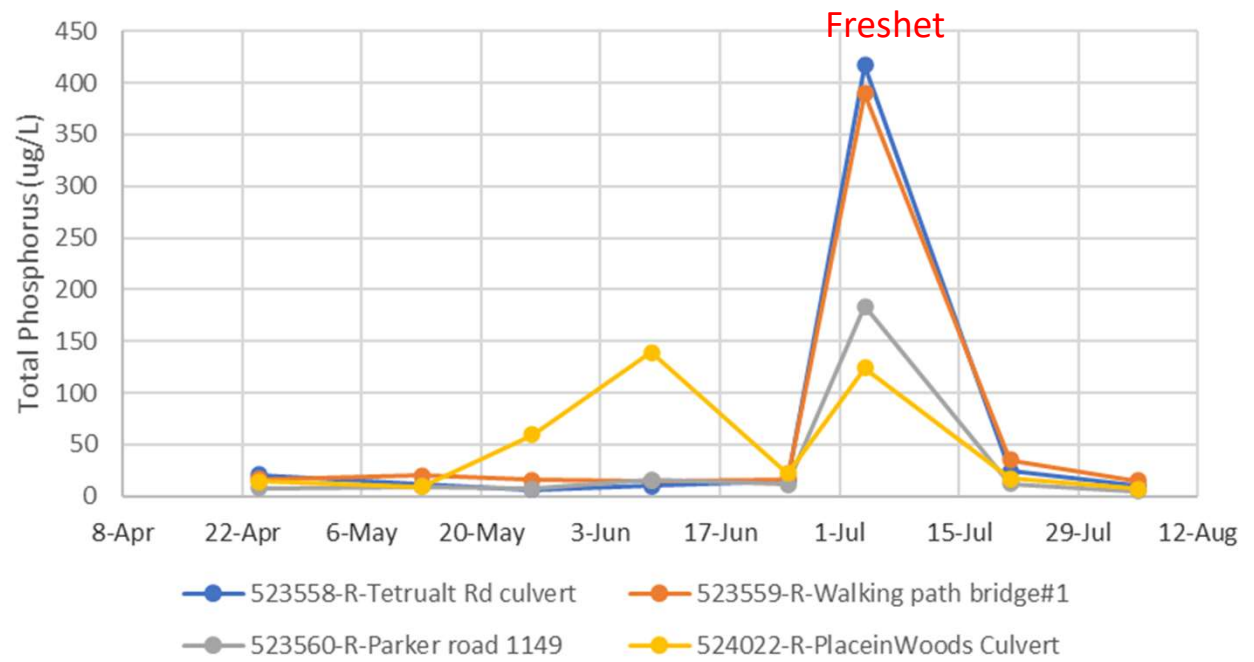
2023 Lake Parker Tributary Total Phosphorus Monitoring

- LaRosa Partnership Program (LPP)
 - 2023 Summary: High TP during Freshet (July 4th flood) at all sites
 - 2024 Next Steps: LPP volunteer continues collecting biweekly samples June through August (align with LMP)

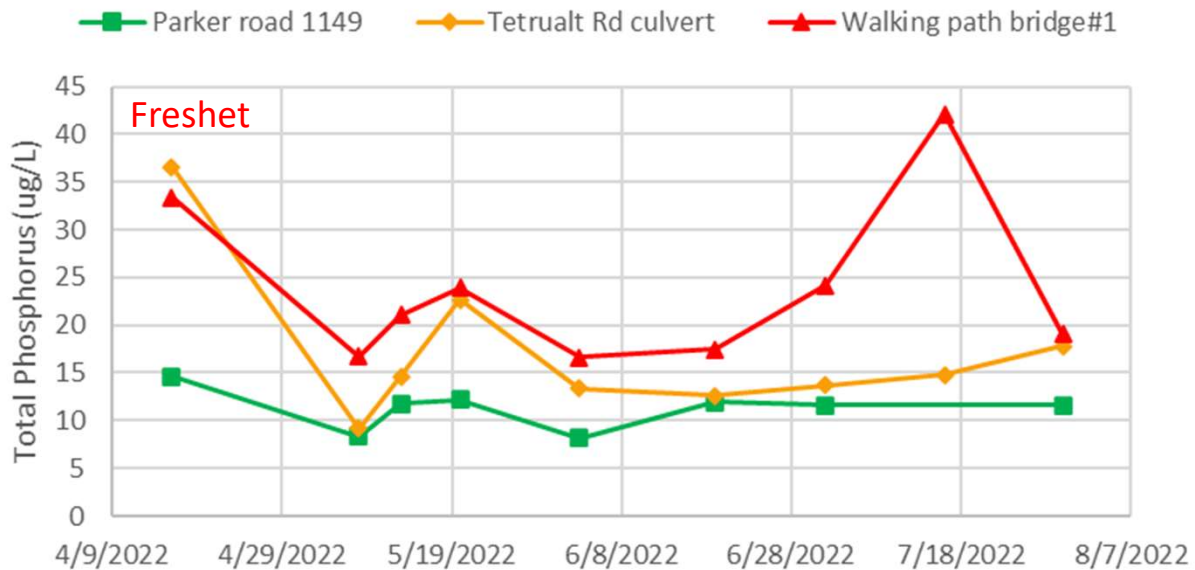
2022 Lake Parker Tributary Total Phosphorus Monitoring Results

Tributary	Minimum TP (ug/l)	Average TP (ug/l)	2022 Max TP (ug/l)
Parker road 1149	8.2	11.3	14.6
Tetrualt Rd culvert	9.2	17.3	36.6
Walking path bridge#1	16.6	23.8	42.1

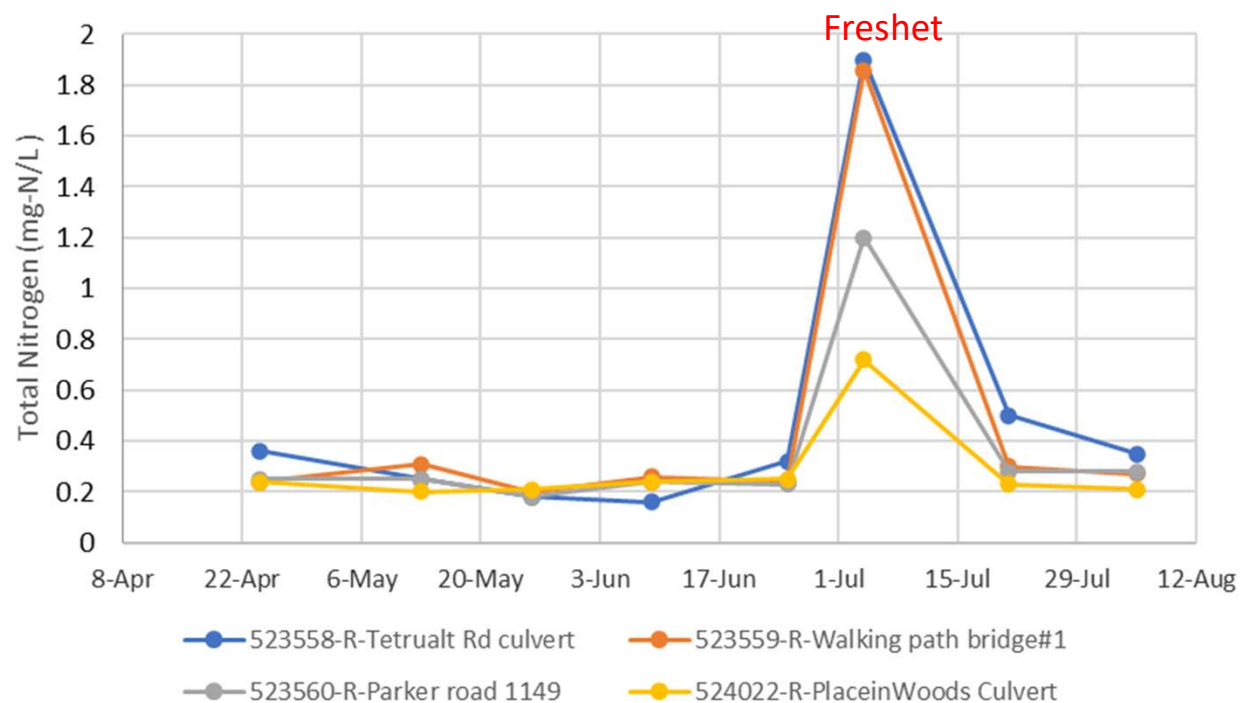
2023 Lake Parker Tributary Total Nitrogen Monitoring

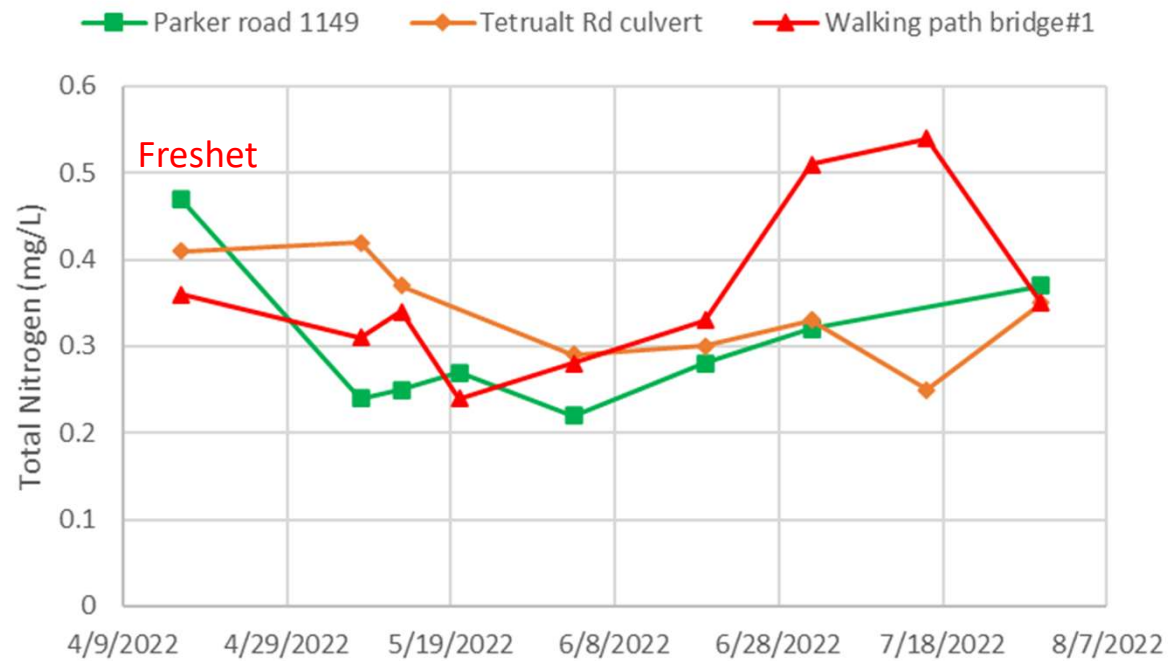
2022 Lake Parker Total Nitrogen Monitoring Results

Tributary Site	Minimum TN (ug/L)	Average TN (ug/L)	Maximum TN (ug/L)
Parker road 1149	0.22	0.3	0.47
Tetrualt Rd culvert	0.25	0.34	0.42
Walking path bridge#1	0.24	0.36	0.54

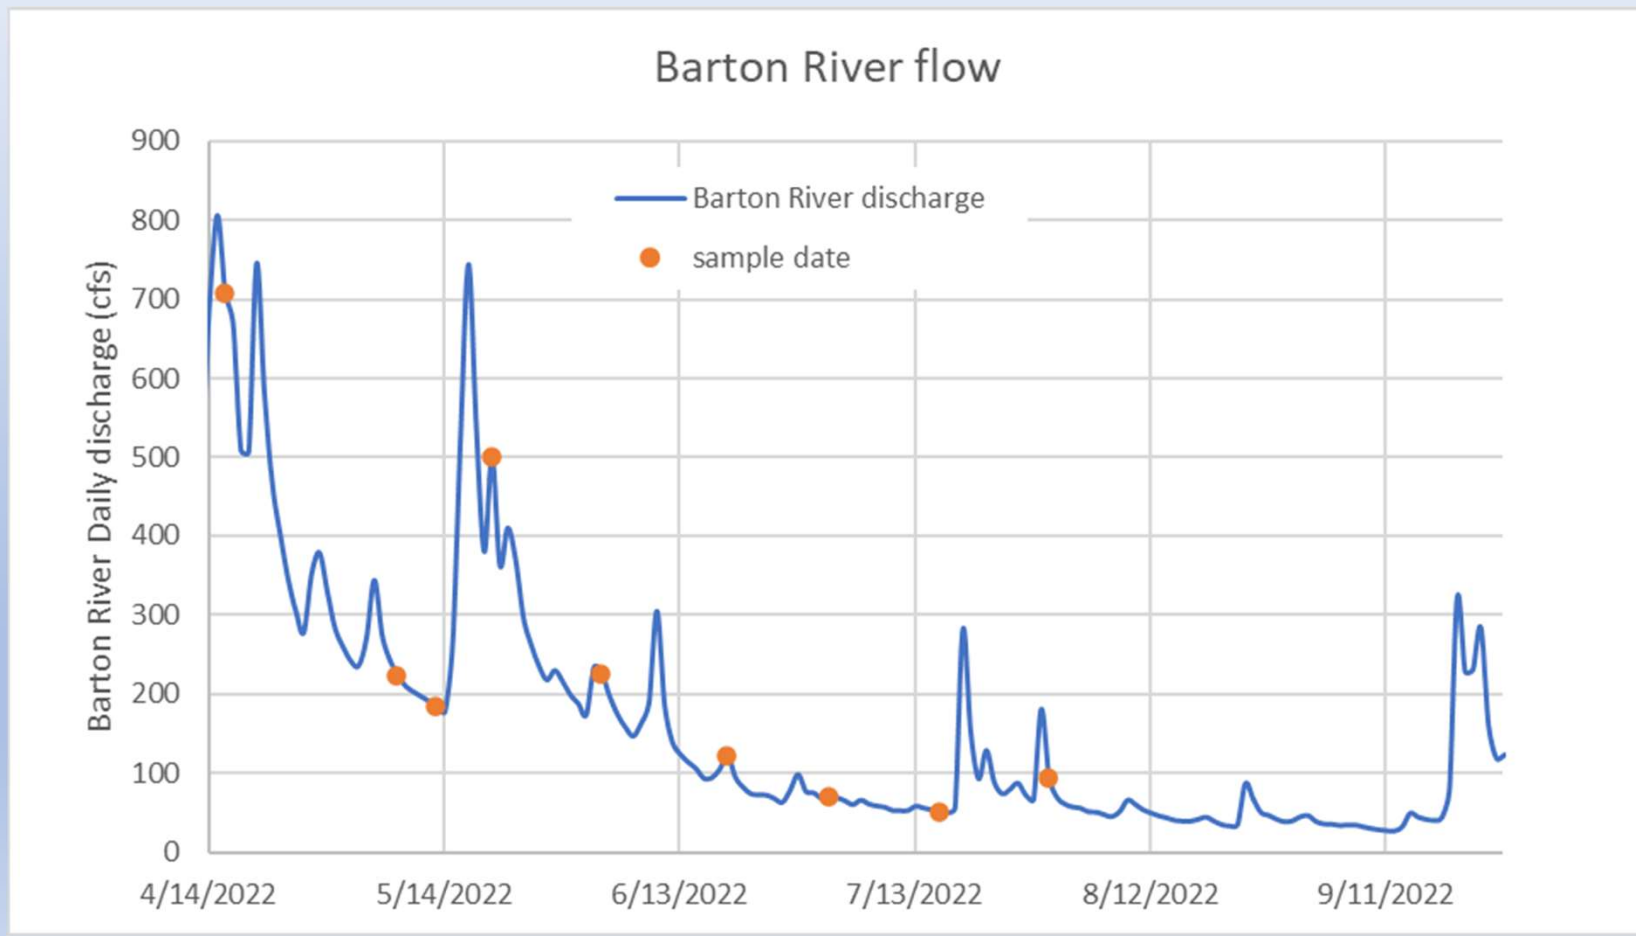
USGS Streamflow – Barton River, Coventry
