2023 Lake Willoughby Water Quality Monitoring Results: Lay Monitoring Program and LaRosa Partnership Program

Mark Mitchell, Limnologist

UVM Lake Champlain Sea Grant and VT DEC Lakes & Ponds Program

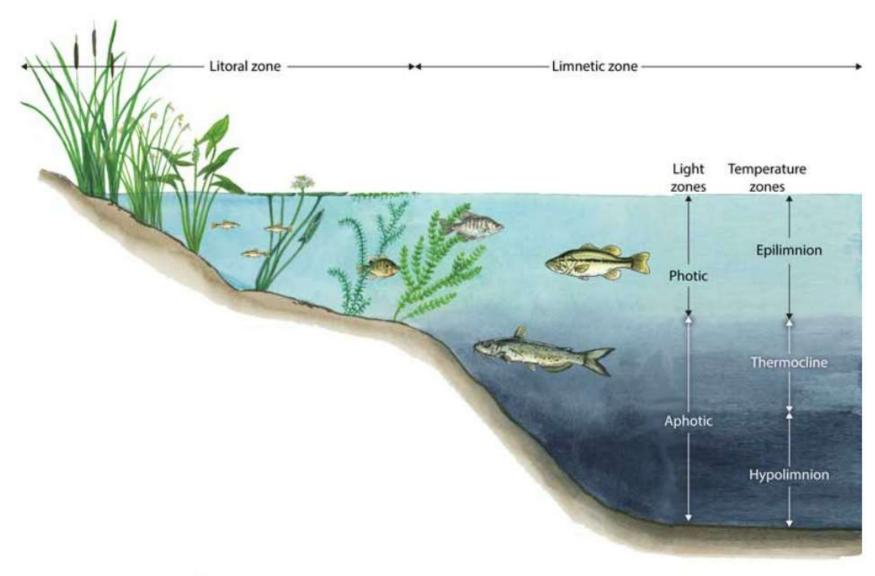
Lake Zones

A typical lake has distinct zones of biological communities linked to the physical structure of the lake (Figure 10). The **littoral** zone is the near shore area where sunlight penetrates all the way to the sediment and allows aquatic plants (**macrophytes**) to grow. Light levels of about 1% or less of surface values usually define this depth. The 1% light level also defines the **euphotic zone** of the lake, which is the layer from the surface down to the depth where light levels become too low for **photosynthesizers**. In most lakes, the sunlit euphotic zone occurs within the **epilimnion**.

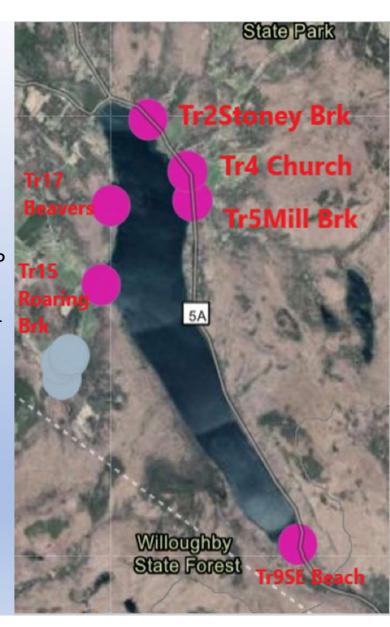
- Tributaries first sampled in 2021 ~biweekly (8X) from April/May to July/August + ~2 storm events
- 515882-Tr15 Roaring Brk: 30% algae cover at inlet 2 and since biology never lies, worth monitoring this tributary
- 523160-Tr17 Beavers: Includes runoff from farmstead and fields, high TP values in past
- 523161-Tr2Stoney Brk: Includes runoff from farmstead and fields, larger watershed, large delta formed at mouth of trib
- 523162-Tr4 Church: Very high CL readings, interesting for FPR as near site where new parking area and restoration projects are going in
- 523163-Tr5Mill Brk: Upsteam Orleans NRCD Sampling to see impact of farm restoration efforts, could be useful to get a downstream value
- 523164-Tr9SE Beach: Very high TP value, needs follow up
