**Petition to the Agency of Natural Resources to Amend  
the Vermont Use of Public Water Rules to Adopt a Rule to Prohibit  
the Use of Watersports on Shadow Lake in Glover, Vermont**

Re: Petition For Prohibition of Wakesports on Shadow Lake

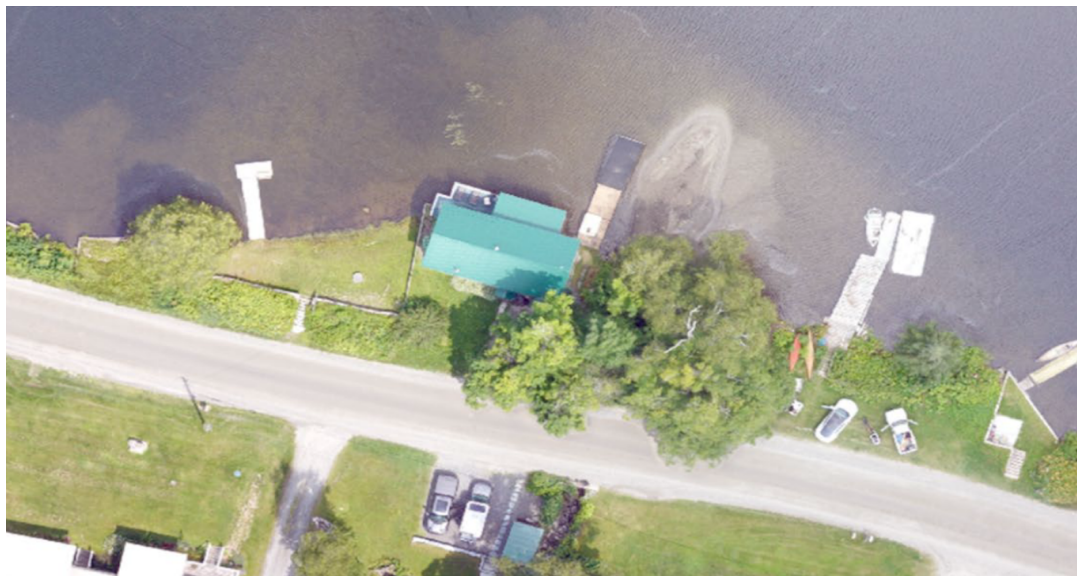
The largest of the severely aggrading deltaic mounds of exposed gravel, sand, mud, and silt measures over 75' X 75' from the culvert daylighting at the shoreline, and the plume of muck and silt extends well over 100 feet outward beneath the lake's surface and laterally. The sediment volume is unstable and will be easily disturbed by the wakesports wave trains power exceeding 100 j/s/m as they hit that vulnerable area. Strong wave disturbance will easily cause the sediments to resuspend, exacerbating phosphorus, heavy metals and pollutants released, that can contaminate the lake and contribute to our rising phosphorous trend, leading to water-quality problems and eutrophication.

*Lake Watershed Action Plan Phase 1 for Shadow Lake - drone photo of shoreline area identified as a priority restoration project*

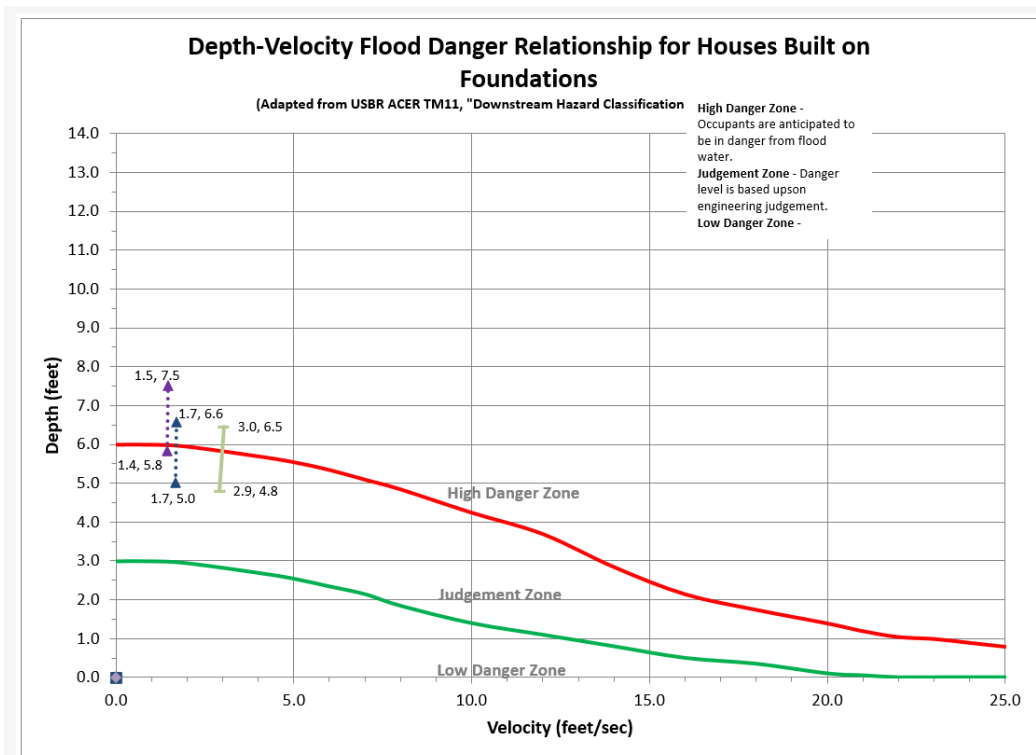
\*Listed depth values show on the chart are taking into account first floor elevation.

- During the 1000-yr dam failure vs 1000-yr no dam failure comparison, four (4) structures were identified that experience incremental flooding rises greater than 2 feet (maximum of 2.98 feet). Of these four structures, two (2) structures plotted in the HIGH danger zone (Red) with and without dam failure. The remaining two (2) structures transition from the LOW danger zone (Green) to the Judgment Zone (Yellow), but both structures end up plotting in the middle to lower half of the JUDGMENT zone, and therefore loss of life was not considered probable. See table below.

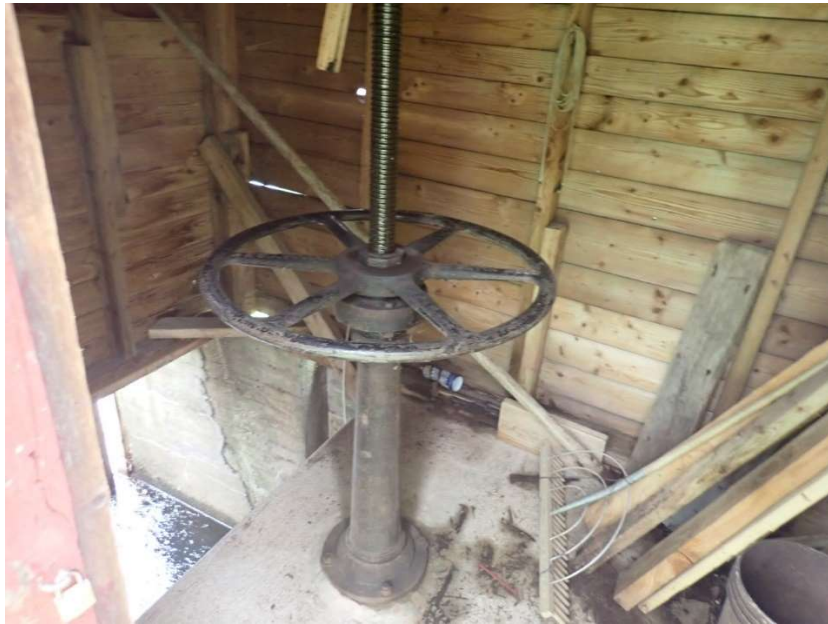
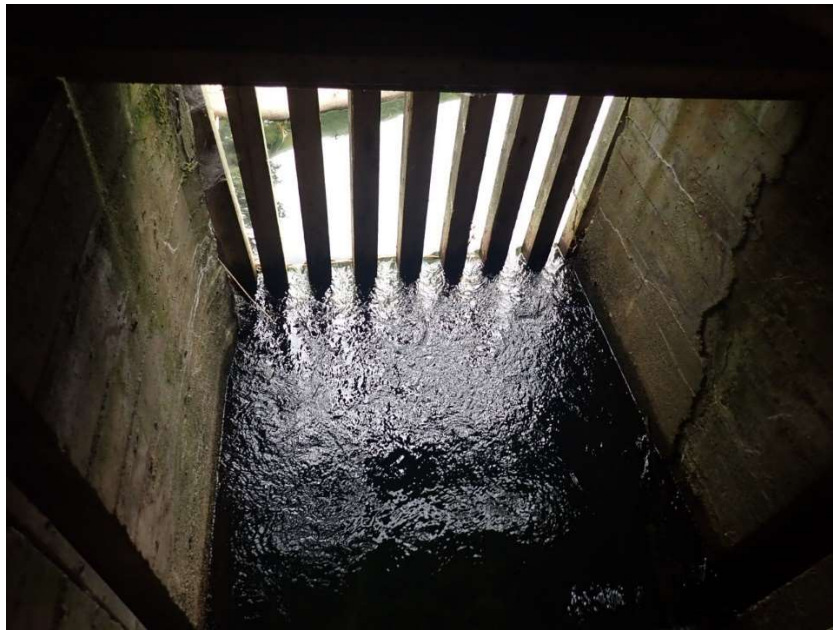
**Principal spillway images**

Additional comments: A timber trash rack sits in front of the principal spillway stop logs to prevent debris from clogging the spillway. The limited spacing in between the vertical bars results in head loss/flow restriction as indicated in the 2022 H&H study. While the purpose of the trash rack is to limit the potential for debris to get into and clog the spillway, it is recommended that the owner test an alternative debris rack configuration or remove some of the vertical bars to reduce the head loss. A dam order (permit) would not be required to perform this work.

The 2022 H&H study also notes that the slide gate partially blocks the outlet of the principal spillway gate house even with gate stem cranked fully open. This does not appear to influence normal flow conditions, but it may limit outflows under high flow events.

There is no standalone low-level-outlet, removal of the principal spillway stop logs would allow for a partial drawdown of the impoundment. The stop logs could not be thoroughly inspected. Observable portions appeared to be in fair condition.

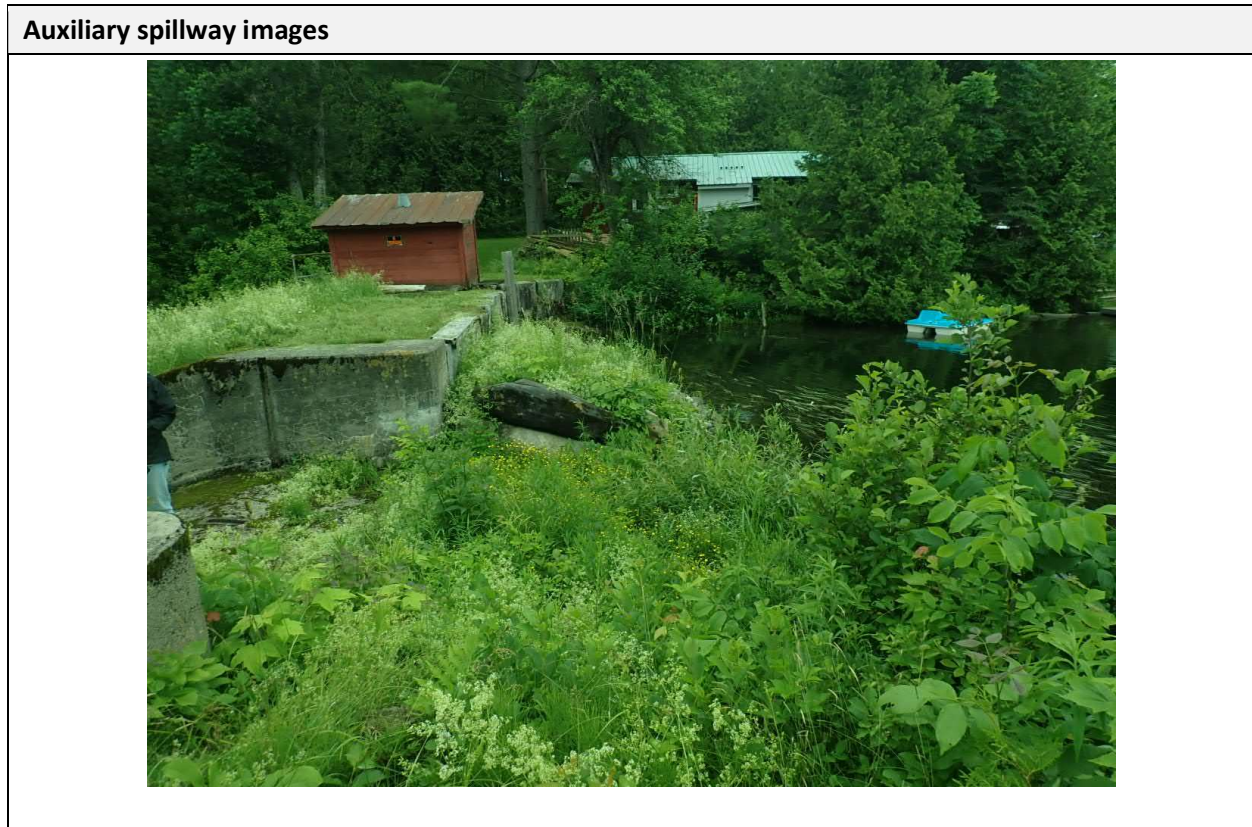
Auxiliary spillway issues	Action
<p><b>Concrete deterioration</b>                      Description: There are visible signs of wear and deterioration along the entirety of the auxiliary spillway. The concrete has been patched/repared in some places along the training walls. Concrete is in fair condition for its age.</p>	<p> <input type="checkbox"/> None  <input checked="" type="checkbox"/> Monitor  <input type="checkbox"/> Maintenance  <input type="checkbox"/> Engineer                     </p>

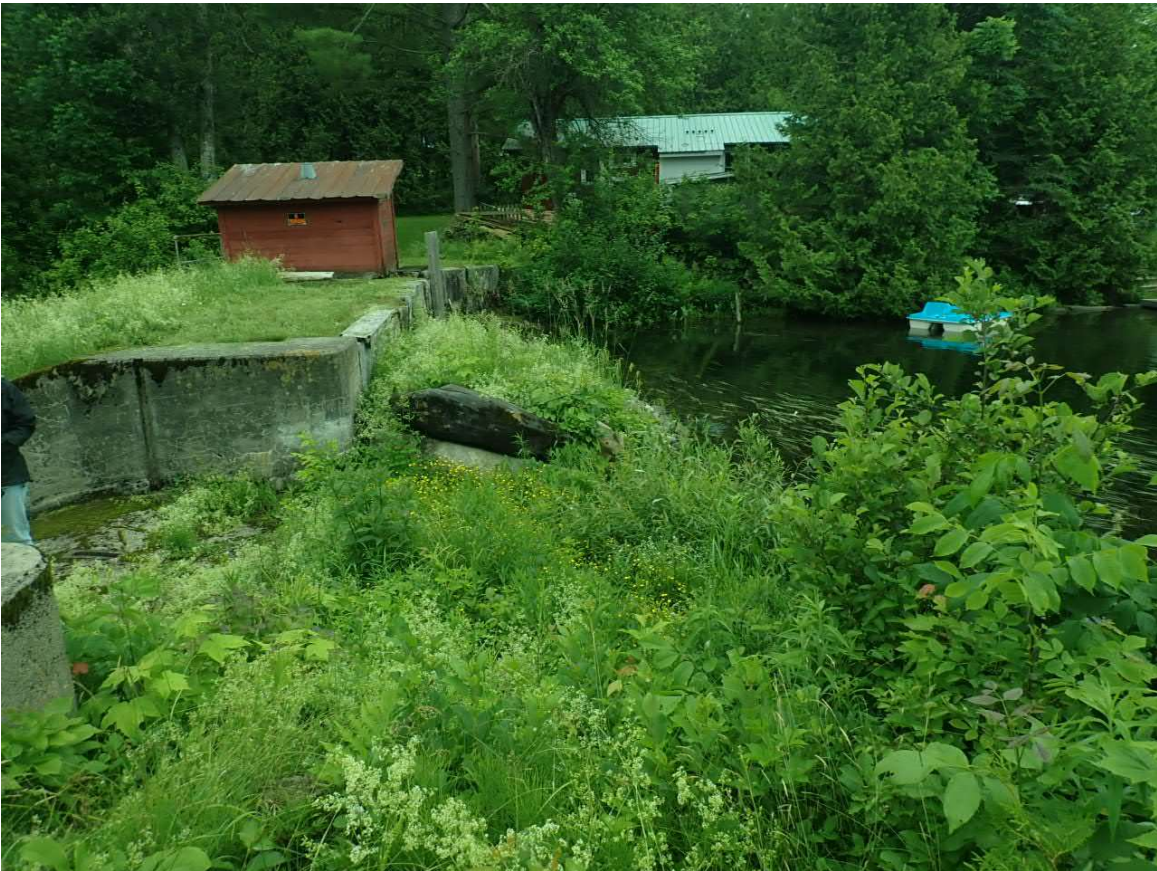
**Upstream wall images**

Upstream Wall		
<b>Wall type:</b> Stone Masonry Length: 130 ft		
<b>Wall height (exposed):</b> 5.2 ft above normal pool	<b>Horizontal wall alignment:</b> Good	<b>Vertical wall alignment:</b> Good
<b>Unusual wall movement:</b> <input type="checkbox"/> Yes <input checked="" type="checkbox"/> No		
<b>Additional comments:</b> Stone/riprap has been placed in front of the wall; tall vegetation is growing on the stone/riprap which prevented thorough inspection.		<b>Surface condition:</b> Fair to Good
<b>Joint condition:</b> Good		<b>Abutment contact condition:</b> Good
